**Flood Control Project Maintenance
Levee Inspections**

Spring 2012 Levee Inspection Results

Reclamation District No. 1500 Sutter Basin

Levee Inspection Report By Mile - Spring 2012

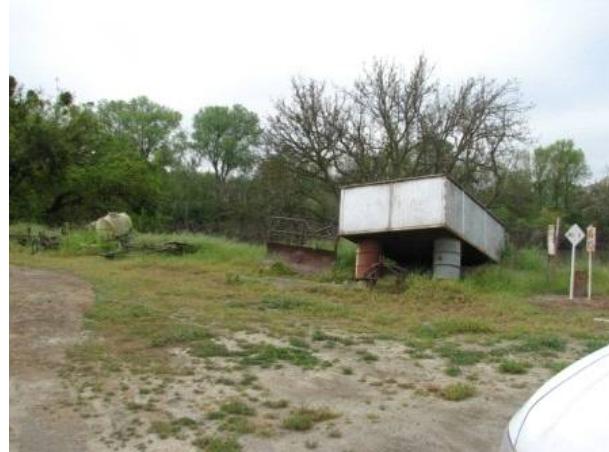
Levee Mile Report Line	1
Start Levee Mile	0.01
End Levee Mile	0.01
Location	Water Side
Category	Earthen Levee
Item	Encroachments
Farm equipment is stored on crown at L.M. 0.0	
<i>johngw_s_20120313_440.jpg</i>

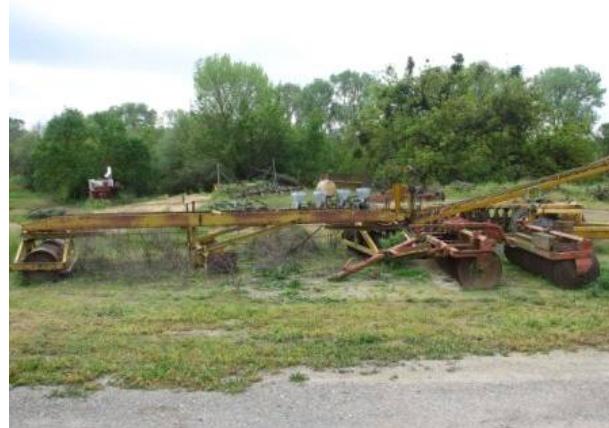
Levee Mile Report Line	1
Start Levee Mile	0.01
End Levee Mile	0.01
Location	Water Side
Category	Earthen Levee
Item	Encroachments
This is another photo of equipment on levee crown.	
<i>johngw_s_20120313_441.jpg</i>

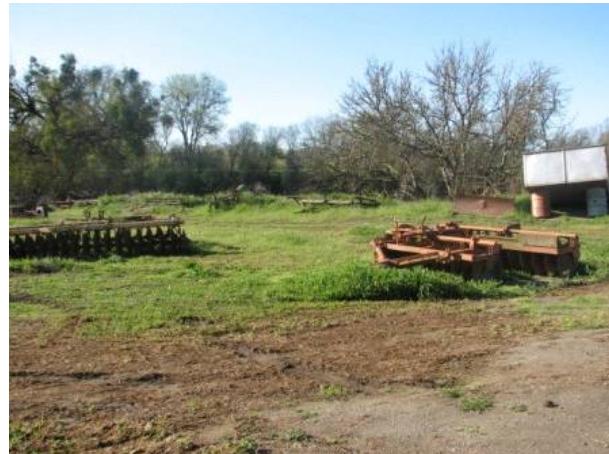
Levee Mile Report Line	1
Start Levee Mile	0.01
End Levee Mile	0.01
Location	Water Side
Category	Earthen Levee
Item	Encroachments
Photo taken spring 2012.	
<i>johngw_s_20120409_643.jpg</i>

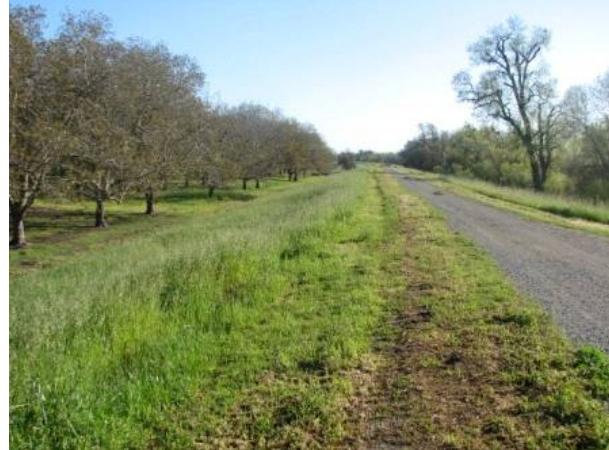
A view of the landside levee slope, photo taken spring 2012.

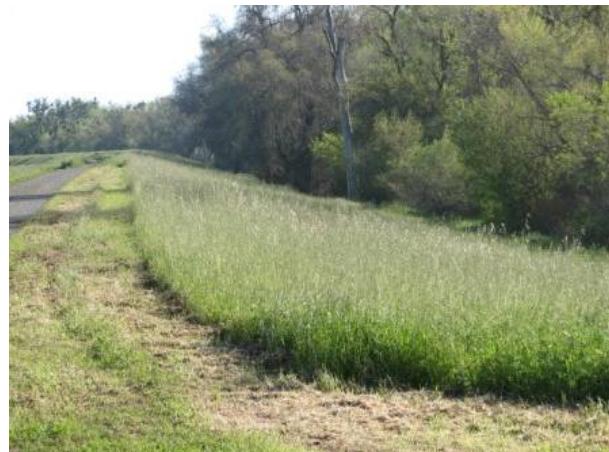
Levee Mile Report Line	3
Start Levee Mile	0.01
End Levee Mile	20.76
Location	Water Side
Category	Earthen Levee
Item	Vegetation

A view of the waterside levee slope grasses are taller than 12", photo taken spring 2012.

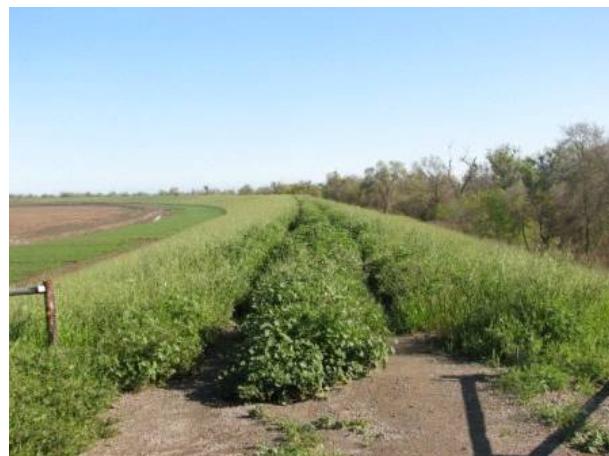
Levee Mile Report Line	4
Start Levee Mile	2.03
End Levee Mile	6.68
Location	Crown
Category	Earthen Levee
Item	Crown Surface / Depressions / Rutting

The crown needs to have weeds controlled, photo taken spring 2012.

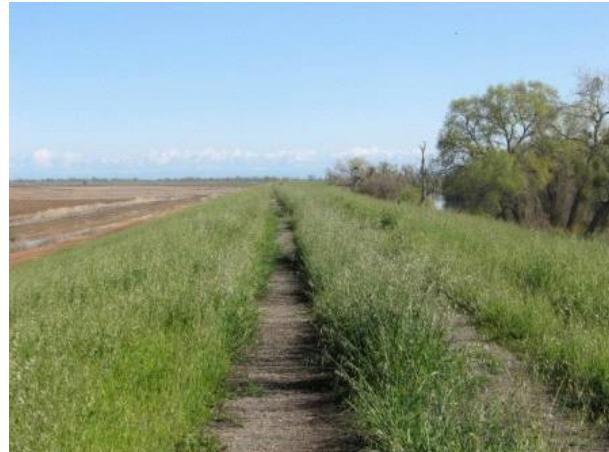
Levee Mile Report Line	5
Start Levee Mile	7.29
End Levee Mile	20.76
Location	Crown
Category	Earthen Levee
Item	Crown Surface / Depressions / Rutting
The crown needs to be controlled for weeds, photo taken spring 2012.	
johngw_s_20120409_649.jpg

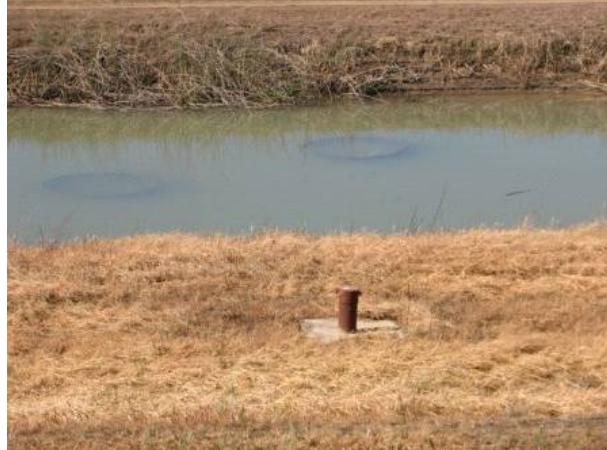
Levee Mile Report Line	8
Start Levee Mile	14.22
End Levee Mile	14.22
Location	Land Side
Category	Earthen Levee
Item	Underseepage Relief Wells
The relief well at boil 12, photo taken spring 2012.	
<i>johngw_s_20120409_650.jpg</i>

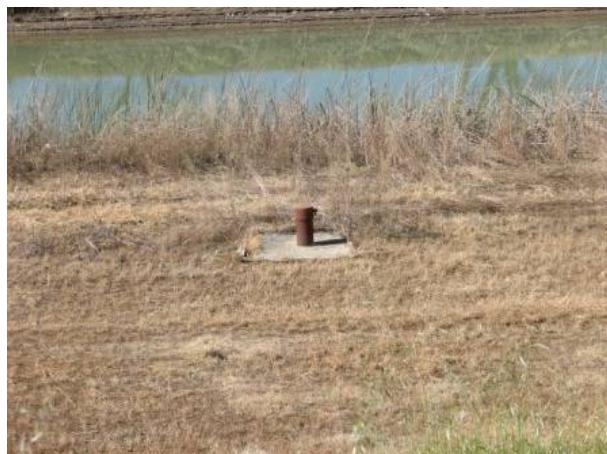
Levee Mile Report Line	10
Start Levee Mile	14.56
End Levee Mile	14.56
Location	Land Side
Category	Earthen Levee
Item	Underseepage Relief Wells
A relief well at boil 16, photo taken spring 2012.	
<i>johngw_s_20120409_652.jpg</i>

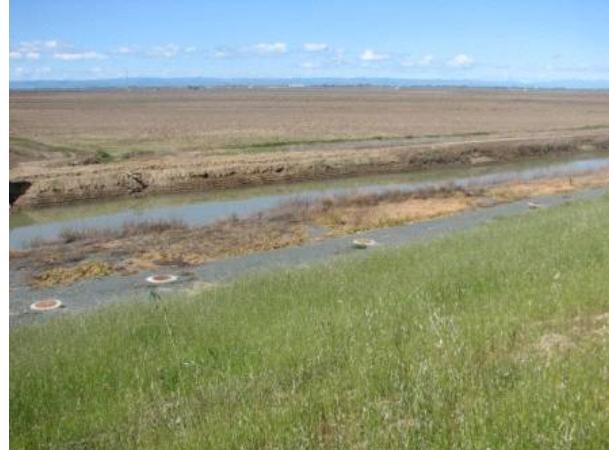
Levee Mile Report Line	11
Start Levee Mile	18.24
End Levee Mile	18.24
Location	Land Side
Category	Earthen Levee
Item	Underseepage Relief Wells
Toe drainage systems along the toe berm four total, photo taken spring 2012.	
johngw_s_20120409_653.jpg

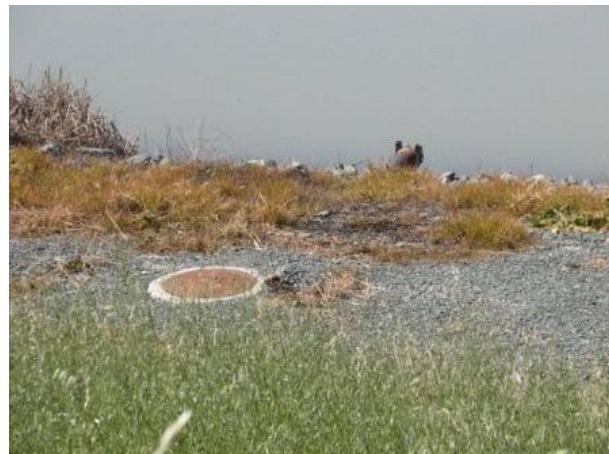
Levee Mile Report Line	12
Start Levee Mile	18.48
End Levee Mile	18.48
Location	Land Side
Category	Earthen Levee
Item	Underseepage Relief Wells
A toe drainage system at the toe berm, photo taken spring 2012.	
johngw_s_20120409_654.jpg

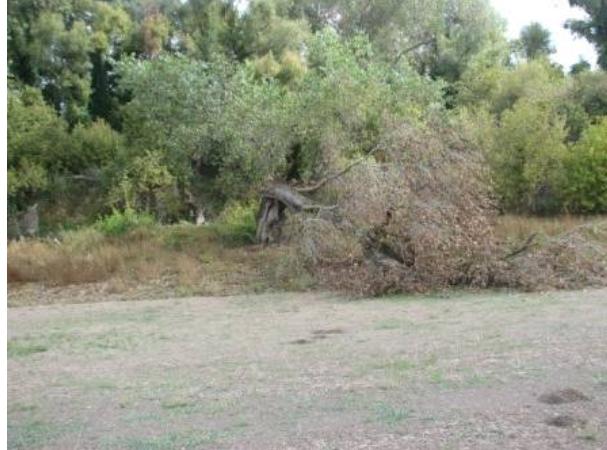
Levee Mile Report Line	13
Start Levee Mile	19.96
End Levee Mile	19.96
Location	Water Side
Category	Earthen Levee
Item	Trim / Thin Trees
The cottonwood tree needs to be cut up and removed off the toe.	
johngw_s_20120313_443.jpg
